# CORROCOAT NEWS

August 2020

## Plasmet ZF – A Runaway Success in Norsok Tests

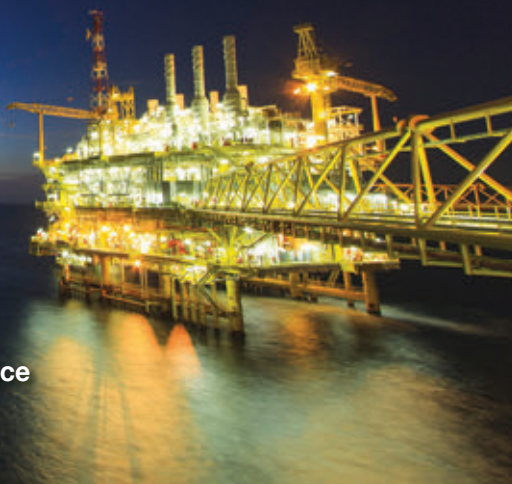
After six-month long exposure tests for cyclic ageing, seawater immersion and cathodic disbondment, the results were received this June and the coating performed extremely well, passing all tests with flying colours.

As testament to the success of Plasmet ZF, SGS commented that the results on the cathodic disbondment tests were “exceptional” reporting that they could not even get a knife blade between the coating and the steel after 175 days on test!

This chart displays the results achieved by Plasmet ZF after cathodic disbondment, seawater immersion and cyclic ageing tests. Visual inspection of the coated sample plates showed no blistering, rusting, cracking and flaking and no chalking – you really can't get better results than that!

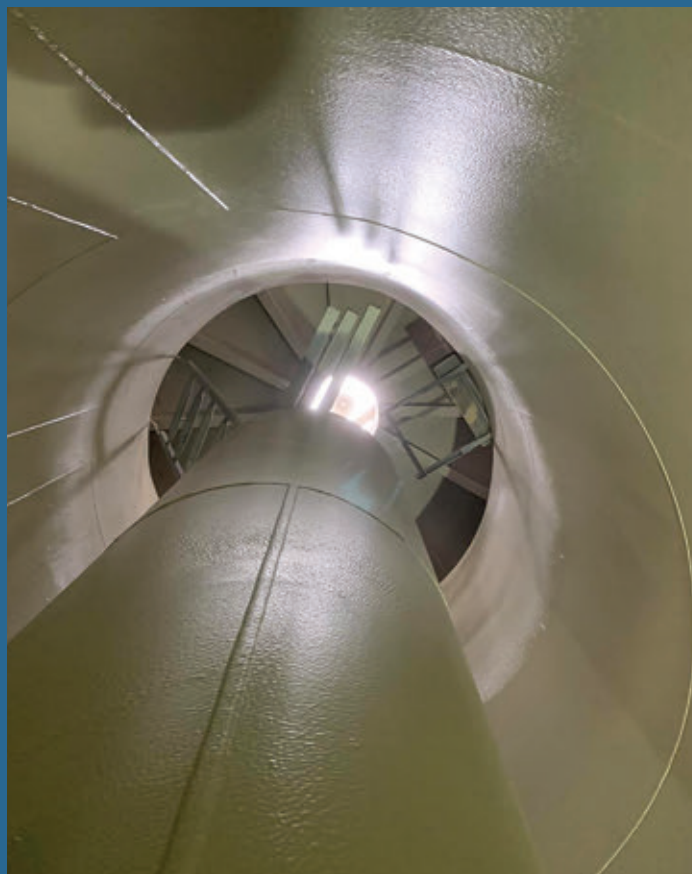
Our Belarusian operation (Corrocoat AKZ) was contracted to refurbish and corrosion protect a water treatment saturator at a major Belarusian power station. The saturator was suffering from corrosion as the operating medium was water with an acidic pH. The client required a coating with excellent corrosion resistance, capable of providing protection for at least 10 years. The work had to be completed during a planned 20-day shutdown.

After the saturator's internals were blast cleaned to ISO 8501-1 Sa 2½, Polyglass VEHA was applied as a stripe coating at the weld areas, edges and joints. This was followed by Polyglass VE spray applied at a minimum DFT of 1000µm. Finally, a top coat of Fluigluid VE was applied at a minimum of 300µm. The total area coated was 980 m², the work being carried out by three teams working in three shifts.

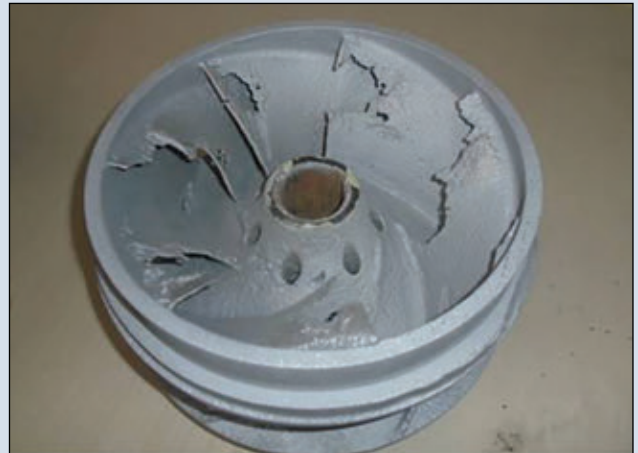
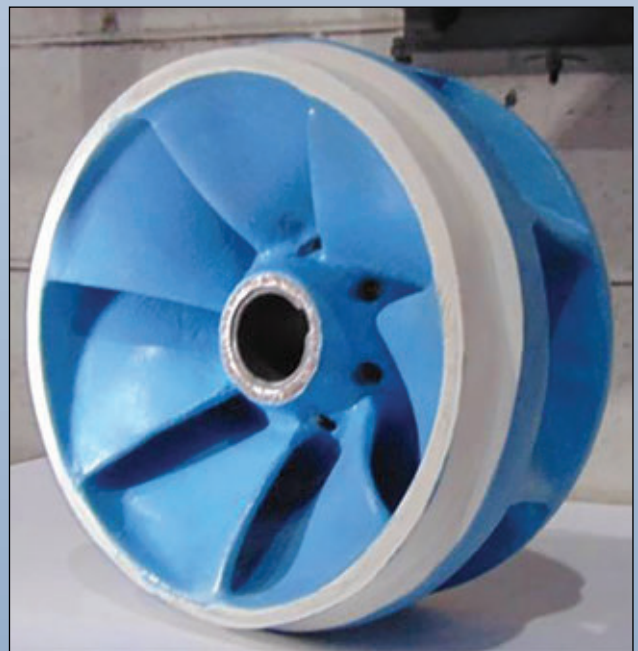
As part of an ongoing service programme for a UK power station, Corroserve received a clarified water pump for overhaul. Once out of service it was noted that the impeller was suffering from severe cavitation within the suction eye area, with considerable loss of material right across the vanes. Due to the amount of damage, the impeller was deemed to be “beyond economic repair” by the client.

After stripping the pump down, the impeller was measured and pre-machined, a template being made from the best surviving vane. All wetted areas were abrasive blast cleaned to ISO 8501-1 Sa 2½ with a blast profile of 50µm. The coated areas were primed using Corroglass 632 and the vane profile built up using 600 laminating resin and multi-directional glass matting. The impeller was then brought back to original thickness using Corroglass 600 series coating. A top coat of Corroglass 652, blue drill guard, was applied for protection.

The impeller was finally post machined back to original sizes, including re-instating the correct wear ring running clearances in accordance with international pump standards and check balanced to ISO Grade G6.3 in accordance to BS6861 Part 1/ ISO standard 1940-1. The client was very satisfied with the quality of the work which was completed at a fraction of the cost of replacement.

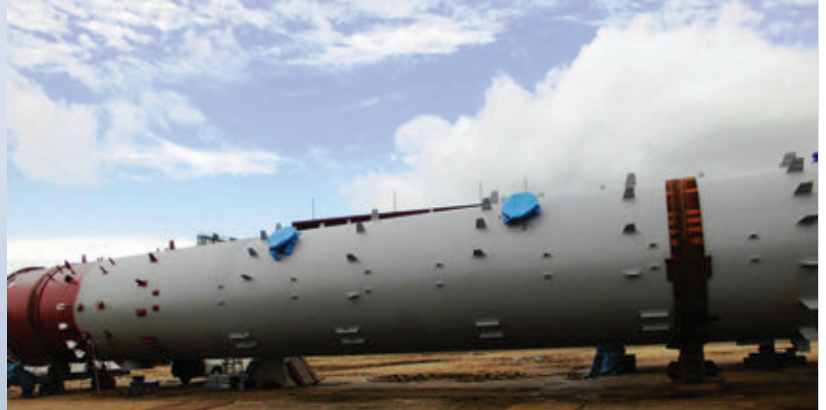
The client requested that a series of pull-off tests be completed to confirm that the adhesion between the two different layers would meet their exacting specifications. Polyglass VEF returned excellent results, demonstrating high levels of adhesion, resistance and compatibility between layers and Corrocoat Japan was awarded the contract.

After suitable preparation Polyglass VEF was spray applied to achieve a DFT of min 500µm. Polyglass VEHA was applied by hand where spraying was not practicable. Spark testing to identify pinholes or holidays was carried out but none were present.

A major chemical processing plant in Japan was looking for a coating system to add further reinforcement to the fibre reinforced plastic lining that was to be applied to a new stainless steel exhaust gas absorption tank. Corrocoat Japan recommended Polyglass VEF due to its superior resistance to chemical attack across the pH range in immersed conditions.

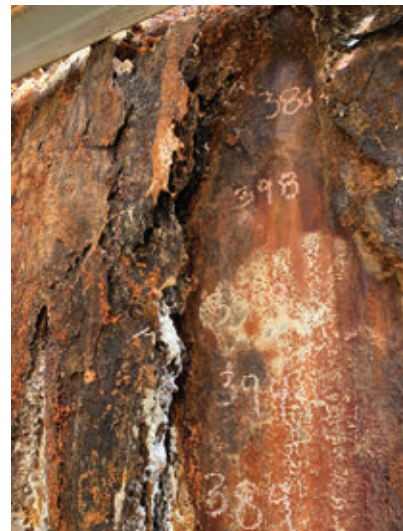
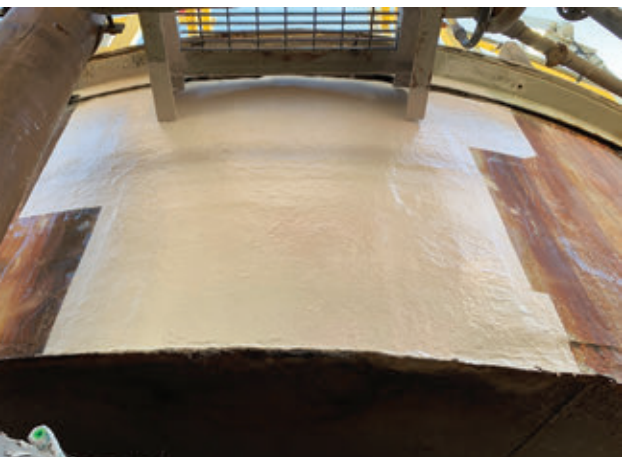
**This process vessel experienced a brick and mortar lining failure resulting in the process environment consuming the carbon steel shell 90ft above ground. A full repair would have required over a week of unscheduled downtime, so a quotation request was sent out to contractors for an external patch that would not further degrade the internal liner.**

The area was scraped carefully by hand, exposing a five foot vertical void in the shell surrounded by smaller voids. The thinner areas near the voids were prepared with power tools to protect the integrity of the liner, the surfaces washed to remove salts prior to abrasive blasting and priming with Corroglass 600 Series.

Corroglass 600 Series is specifically developed for process internals, resisting chemical laden environments. It includes a lamination resin and barrier linings of three different viscosities that can hang at up to 3mm without sagging and be applied wet-on-wet in films of up to 8mm eliminating the long wait times between layers with other composite repair systems.

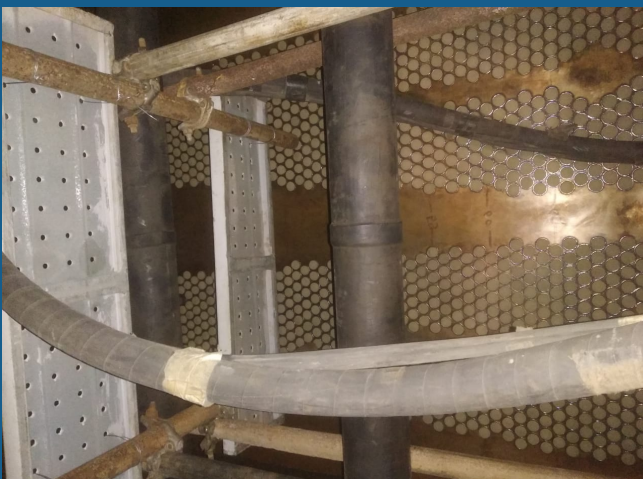
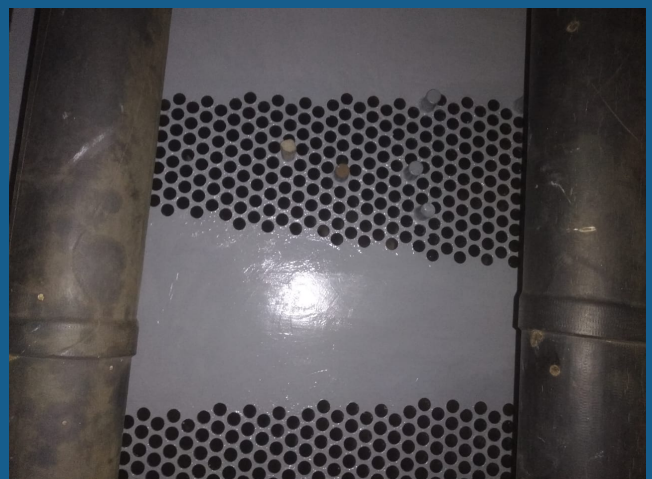
**Over the past two years Corrocoat Indonesia has been working at two coal fired power stations located in Pacitan City in East Java for PT. PJB UBJOM. Both 315mw power stations required work on the inlet/outlet tube sheet condensers which were suffering from leaks on the welded joints of the titanium tubes. This damage was affecting the efficiency of the heat transfer and allowing steam to escape.**

Corrocoat Indonesia recommended coating the affected tubes – a total surface area of 120m<sup>2</sup> – with Plasmet HTE at 1000-1500µm DFT. HTE contains stainless steel flakes,

glass flakes and silicon carbide making it the ideal choice for areas requiring abrasion resistance.

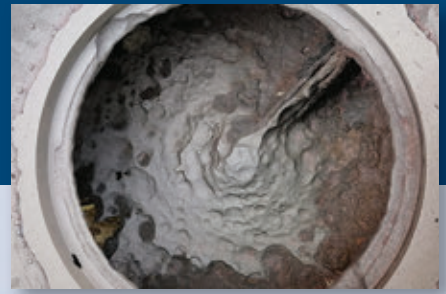
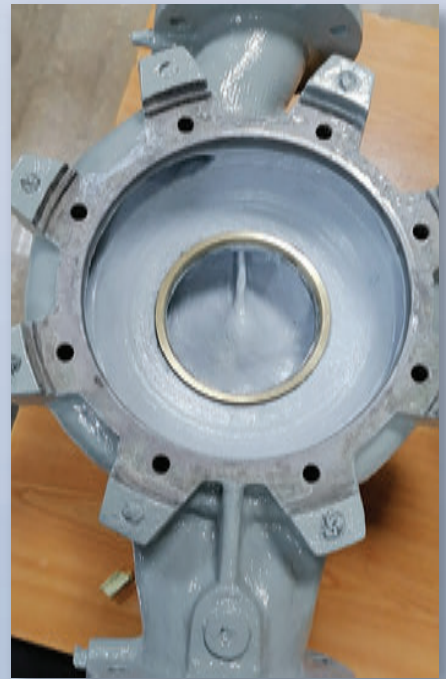
Al Huda Corrosion Treatment, our partner in Qatar, took delivery of a severely damaged sea water pump in need of complete refurbishment and a protective lining. Al

Huda's client – MILAHA, a specialist pump company described the pump as having severe corrosion and erosion damage and metal loss, all of which needed to be addressed.

Abrasive blast cleaning revealed the true extent of the damage and Al Huda's technicians used Corrofill E and Plasmert HTE at a DFT of 1200µm to repair and line the pump internals. The external required a combination of weld repairs, composite lamination to add strength and Corrofill E before a final top coat of Plasmert ZF was applied to offer all round protection.

The shaft was cleaned and reinstalled in the pump along with a new impeller and new mechanical seals, before a pressure test to 1.5 times its service operating pressure to ensure the quality of the work completed.

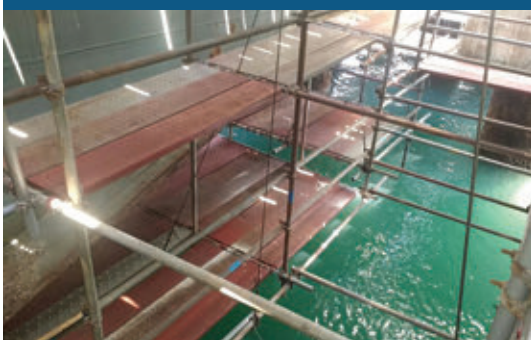
India's largest EPC conglomerate has constructed massive ship lift facility in Southern India capable of lifting a ship of 200m length and width up to 43m. Essentially the ship lift is an enormous elevator used to raise ships out of the water to enable dry-dock onshore maintenance work to be completed. The continuous lifting and lowering means the ship lift platforms are continuously in the splash zone and at risk of corrosion due to continued wetting with salt water and exposure to oxygen rich air.

Originally coated in shop in 2011 by another company, after six years' service it was evident that recoating work was required. The job would require a host of technical and site management skills and KCPL Corrocoat was successful in securing the contract.

After some test procedures had been carried out it was decided that vapour blasting was the best solution to adequately prepare the lift surfaces for coating. Polyglass Zipcoat was then applied to achieve a DFT of 1000µm. Zipcoat provides durable corrosion protection in aggressive atmospheric conditions and immersion environments. In all, some 1500m<sup>2</sup> was blasted and coated and the project was completed on time in March 2020.
