# CORROCOAT NEWS

February 2020

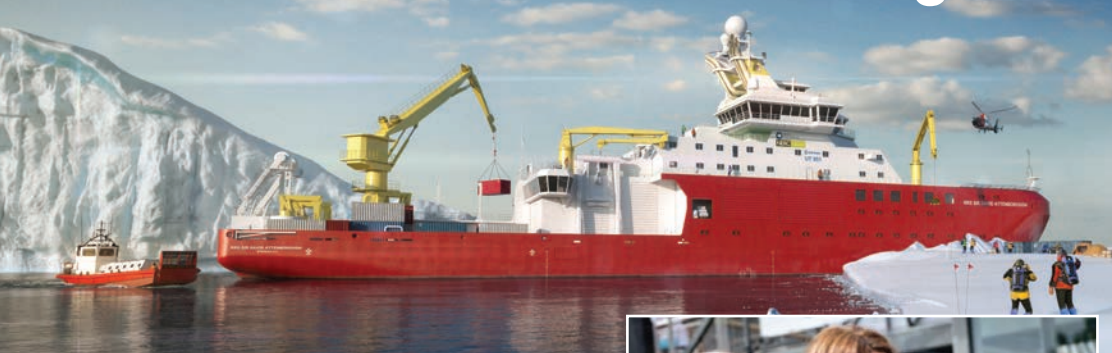
The RRS Sir David Attenborough, built by Cammell Laird for the British Antarctic Survey, is one of the world's most advanced polar research vessels. Corroserve was asked to provide corrosion protection against seawater for a large number of seawater pipes due to be installed on the ship.

The pipespools and slip on flanges were delivered to the company's Leeds workshops where after suitable preparation Corroglass 600 was applied in multiple coats, using the Agmec internal pipe spaying method, to achieve the desired level of corrosion protection.

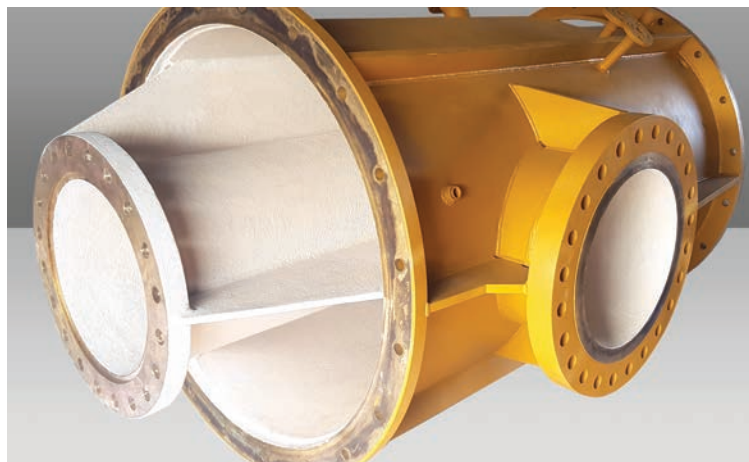
It was delivered to Uni-Arabs workshops, having been abrasive blast cleaned by the contractor, where a full inspection was completed. The surface profile was found to be in line with the requirements of the specification measuring  $65\mu\text{m}$  and salt tests revealed contamination levels of  $0.5\text{mg}/\text{cm}^2$ .

Polyglass VEF and VEHA were applied at a DFT of  $1500\mu\text{m}$  to provide comprehensive protection against seawater corrosion. A series of QA tests were conducted after curing including spark tests and no pinholes were found in the completed coating surface.

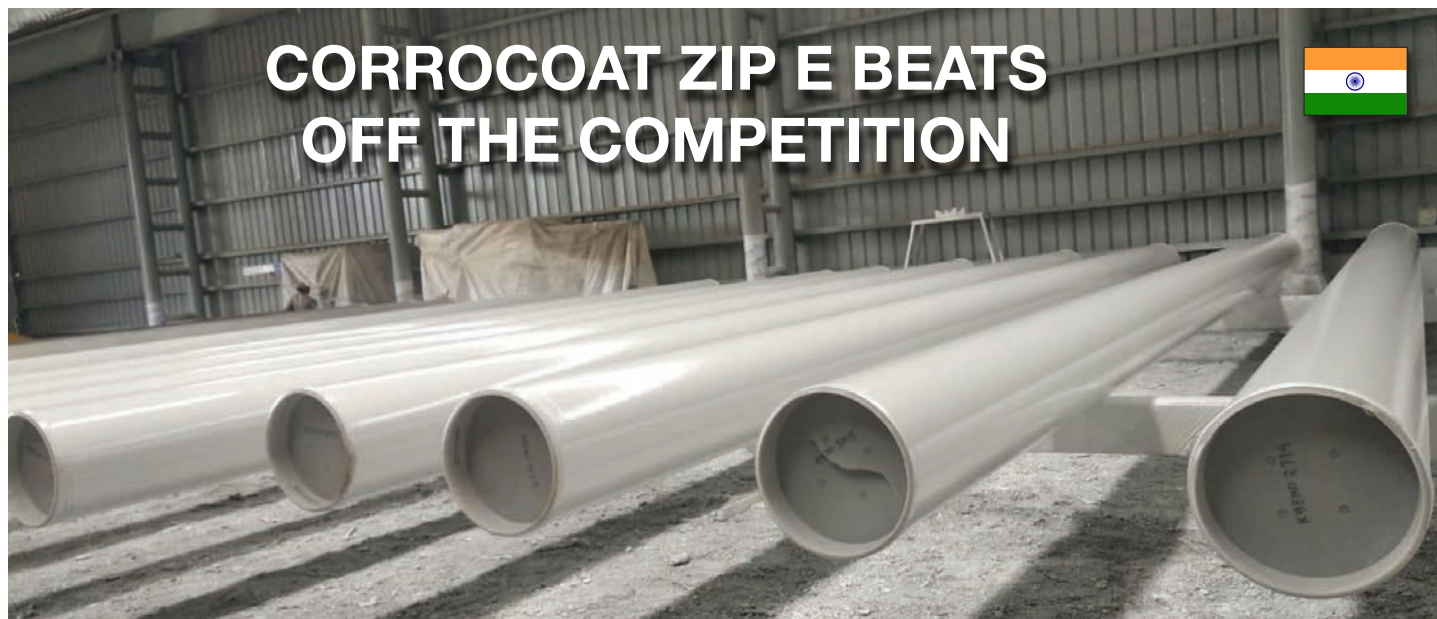
**The coast of India is home to a number of large petrochemical and power industries. Kirloskar Corrocoat Private Limited has a proven and reliable track record in internal and external pipe coating to protect against the saline atmosphere found at the coast and against soil corrosion of underground pipelines.**

In an expansion project, one of India's leading crude refining and petro chemical companies required corrosion protection for stainless steel pipes which were to be buried in the coastal belt in chemically aggressive soils. The pipes would require a proven coating to protect them and extend their service life in these testing environments. KCPL's pre-tendering efforts successfully

replaced technologies such as 3LPE etc. Corrocoat Zip E – a glass flake was specified to protect the pipes.

The overall pipe installation project was awarded to a contractor (LSTK) with whom KCPL had an agreement to coat the pipes with Corrocoat ZIP E at 1000µm- the specified DFT. For organisational efficiency KCPL technicians carried out the coating works at the pipe manufacturer's premises.

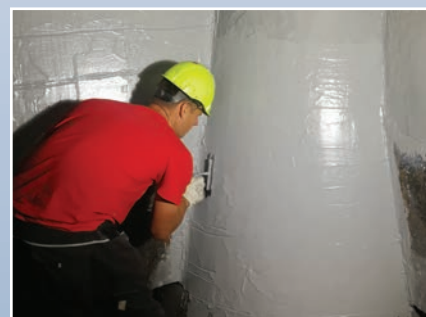
The dividing cones inside a slag residue silo, manufactured from Hardox 500 steel, were subject to a constant abrasive environment. The client required a solution that would prolong the overall expected service life of the steel cone structures by applying a protective, abrasion-resistant coating over the steel structure.

The surface of the cones was abrasive blast cleaned to ISO8501-1 Sa 2½ to achieve the required cleanliness level and a Soluble Salts Attendance Test (Bresle Method) was conducted before priming with Rezorect 198.

Corrofill E was applied by hand to smooth all welded areas and irregularities, and a lamination layer applied to critical areas using Epoxy Laminating Resin and multiaxial glass fibre cloth 600g/m².

Rezorect 125 was then applied, again by hand, in two layers to a desired thickness of 8mm, and following a suitable curing period, DFT and holiday detection tests were completed to ensure the quality of the work completed.

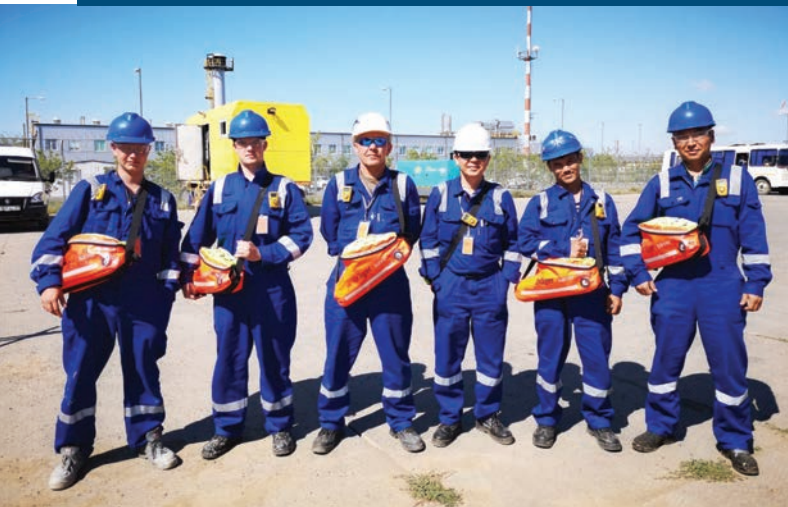
**During September and October 2019 Corrocoat Caspian was appointed by KPO (Karachaganak Petroleum Operating b.v.) as a key contractor for the lining of process vessels during a shutdown event which happens only once every five years.**

Corrocoat Caspian was required to mobilise more than 100 operatives and all their equipment, including 18 airless pumps, to line 50 process vessels with Corrothane XT. The material was manufactured by Corrocoat in Almaty. Corrothane XT was selected because of its resistance to Karachaganak's harsh processing conditions.

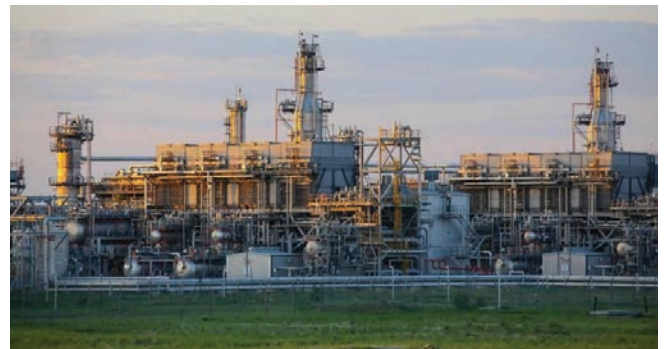
**In Qatar, Al Huda Corrosion Treatment was asked by Petrotech to inspect and recommend a coating system for internal corrosion protection of a hydrocyclone and its band lock. The hydrocyclone is used to separate two liquids of different densities, which in this case was oily water as well as sand creating an abrasive in-service environment.**

After inspection Al Huda recommended coating the cyclone with Plasmet HTE on the internal surface and door where heavy abrasion could be expected. Polyglass VEHA was used to rebuild the band lock closure areas to ensure the vessel could be completely sealed.

The vessel's various internals and door surface were pre-machined to undercut 2mm from the internal diameter and from the band lock surface. Abrasive blast cleaning using steel media was completed to Sa 2½ in order to completely remove a previous failed lining. A minimum surface profile peak of 75µm was also

The performance of the finished coating in service conditions is reported to be excellent after a pressure test was completed on the hydrocyclone at 1.5 times operating pressure with no leakage detected.

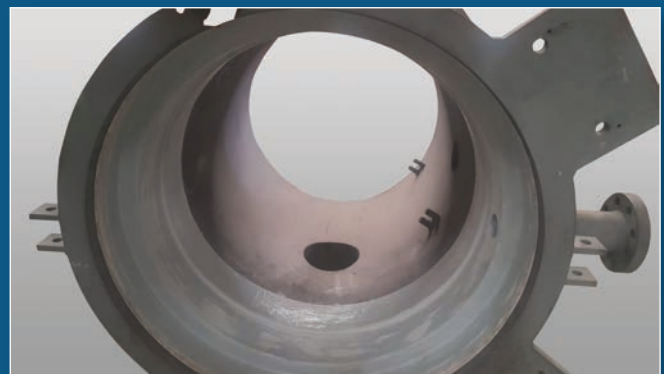
specified. The coating procedure started with a priming coat at a DFT of 300µm, followed by a second coat of Plasmet HTE to reach a DFT of 2200µm.

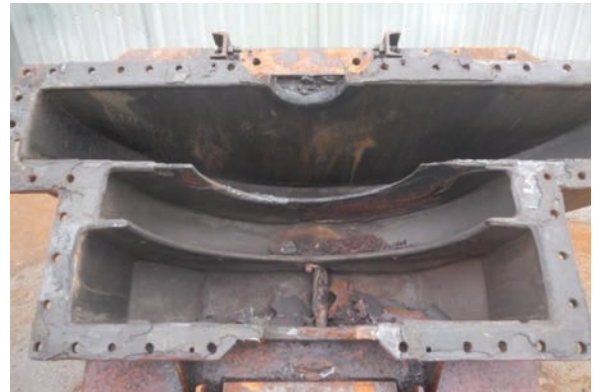
Vietnam Glo Coating Engineering JSC (GCE) was required to refurbish, repair and coat a casing of an inert gas blower by plant operator Pvtrans Oilfield Services. The casing had in the past been coated with a rubber lining which would need to be completely removed as part of the work using UHP water jetting and hand tools where applicable.

The internal surfaces were first abrasive blast cleaned to the required cleanliness level. A primer coat of 632 was applied initially followed by a build coat of 602-632 before the application of a final coat of Corroglass 652 dyed blue. All three coats achieved a combined DFT of 1800µm. GCE also fabricated new EPDM rubber gaskets for the gas blower casing.

The externals of the casing were prepared with a high pressure wash down to remove any oil and contaminants. It was then abrasive blast cleaned and two coats of Plasmet ZF and final top coat of industrial enamel were applied to complete the work.

The before and after images speak for themselves regarding the professionalism and quality of the work completed and the client was very pleased with the refurbished casing.

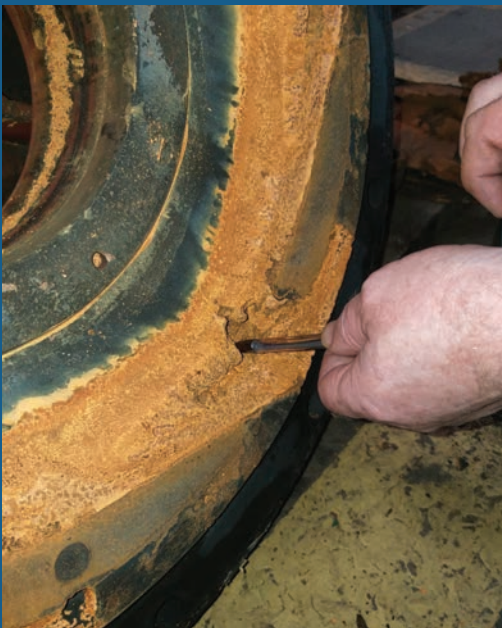
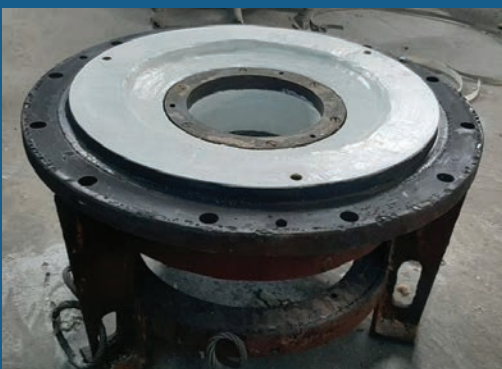
Corrocoat's Belarusian partner (Corrocoat AKZ) was recently commissioned to complete the refurbishment and corrosion protection of a cast iron condensate pump casing at a power station. The pump had been in operation for circa 10 years; pumping water at a temperature of 20-60°C with thermal spikes up to 70°C. On inspection it was found that the pump casing's internal surface had suffered from cavitation and erosion wear. The depth of corrosion pits was in the range of 10-15 mm and the whole casing surface needed to be restored to original condition.

The client required a coating with excellent erosion and cavitation resistance and AKZ proposed the following, which was accepted. The internal surface of the pump casing was abrasive blast cleaned to ISO 8501-1 Sa 2½, after which Corrocoat EA was applied as a filler in the deep pockets of the eroded areas. This was followed by a top coat of Corrocoat EB at a minimum DFT of 2000µm.

As a result of the refurbishment and relining, the pump casing was restored to the required thickness and the applied coating system will provide resistance to the effects of cavitation for a long period. The client was extremely pleased with the outcome of the work and with the savings achieved when compared to the cost of replacement.

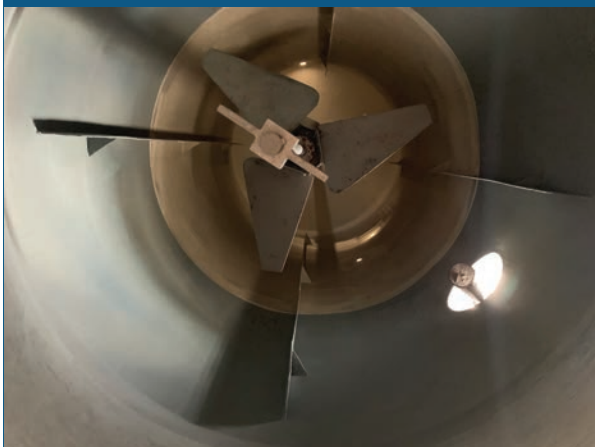
**A vessel at a fragrance plant was used for mixing geranoil, acetic acid, and dosing with 50% NaOH. The neutralisation of the 50% NaOH in the process produces highly corrosive sodium acetate, a soluble salt which in just six years had effectively destroyed a previous epoxy coating and had begun to corrode the vessel itself.**

After required welding repairs were completed the entire tank was blast cleaned and then washed to remove soluble salts and then blasted again to a SSPC-SP10 quality. A holding primer was applied to the prepared surface prior to all pits being filled, all edges and transitions being laminated, and stripe coats applied to weld overlay sections. In areas of heavy localised pitting a layer of fiberglass provided increase strength as well as corrosion resistance. Flanges and nozzles were laminated prior to being coated to provide increased protection in these failure prone areas.

On completion of the preparation work the barrier coat (Polyglass VEF) was spray applied to a thickness of 1200µm. After the initial cure an additional coat of Polyglass VEF WR was applied over the barrier coating at a thickness of 600µm.
