# CORROCOAT NEWS

September 2018

## MASSIVE BIOMASS STORAGE TANK GETS THE CORROCOAT TREATMENT

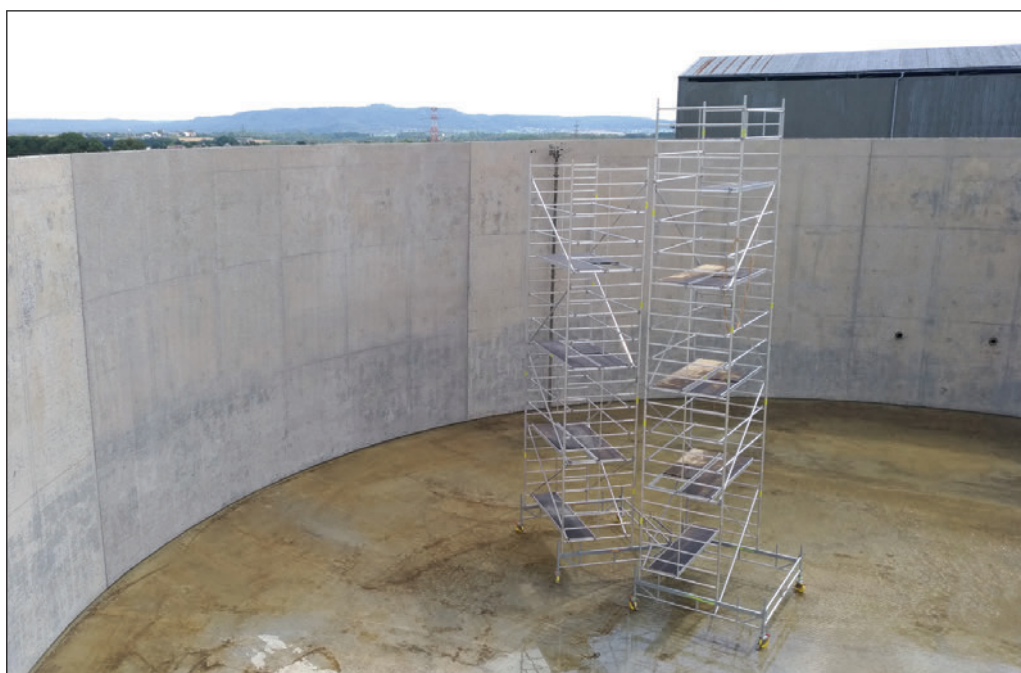
Our partners in The Czech Republic – CorroTech were commissioned by ŠKO-ENERGO to repair and recoat the interior walls of a 35m dia x 8.8m high biomass storage tank – an area of 1003m<sup>2</sup> in all.

The surfaces to be coated were cleaned and prepared by a combination of wet abrasive blasting and ultra high pressure water jetting at 2500 bar. This was followed by the repair of surface air voids and cracks. These were fully exposed then primed with two coats of Polyglass WCP before being filled with Corrofill VE.

The cracks were laminated with L600 and 390g fibreglass matt and Corrocoat Renderpol was applied to ensure the integrity of the damaged areas. The walls were then treated with two coats of VEF at 500 µm. Despite a long period of heavy rain the contract progressed to schedule and will be completed on schedule.

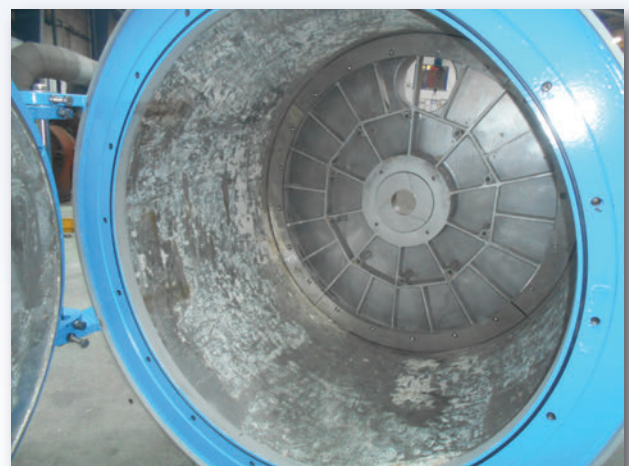
Corroserve received an enquiry for a coating system to protect the insides of stainless steel fibre sorters which are used in the screening of paper grades. A Corroserve engineer inspected the units and was advised that various types of linings including epoxy and elastomeric epoxy products had been tried but, in the customers own words: "had 'disappeared' due to the highly abrasive nature of the contents." The customer had also tried ceramic tiles, but over a short period of time the tiles disbonded from the grouting material and then travelled through the system blocking the filters and disrupting production.

Corroserve proposed the application of an abrasion resistant coating system - Plasmet HTE. A trial was carried out on a steel test plate which was coated and attached to the shell of the unit and placed in service. The system performed well and a quotation was provided. The Corroserve package was to remove any existing failed coating and tiles, surface preparation and the application of the Plasmet HTE coating system.

- Machined surfaces and uncoated areas were masked and protected prior to preparation.
- Any existing lining was removed and the stainless steel substrate abrasive blast cleaned in accordance with ISO 8501-1 Sa 2 to achieve a surface profile of 75  $\mu\text{m}$ .
- A primer coat of Corrocoat EP1 was applied.
- The full surface area was laminated using Multiaxial glass fabric wetted out with laminate resin and rolled into place.
- Plasmet HTE was applied to achieve the specified minimum DFT of 2000  $\mu\text{m}$ , increasing to 3000  $\mu\text{m}$  in heavy wear areas.
- The system was spark tested to ensure the coating is free from holidays and pin holes.
- On completion the coating was post-cured at 60-80°C for at least 8 hours to ensure full cure and provide the best abrasion resistance.

As the unit flexes during operation, the Multi-axial glass fabric provides additional structural strength to the coating system. Plasmet HTE provides the unit with excellent abrasion and erosion resistance and also provides superior resistance to chemicals across the full pH range and many solvents.

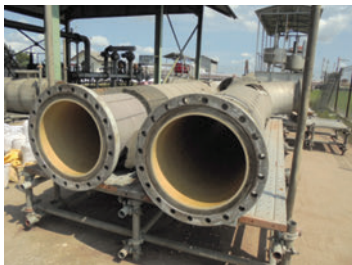
This oil refinery has a prover loop metering system to measure the amount of oil entering and leaving the refinery. However, this was occasionally out of commission due to corrosion on the internals

of the pipework. Corrocoat's proposal was Polyglass VEF at 750 µm and Polyglass VE Veilcoat at 250 µm to provide long term corrosion protection and a smooth finish to allow the "pig" or metering system to flow effortlessly and provide accurate readings. An Agmec pipe blaster and sprayer was used on this contract.

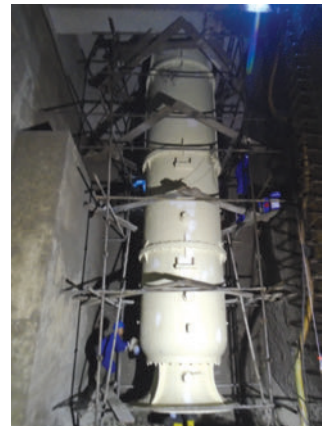
This coal fired power station uses carbon steel CWP pumps to supply sea water to this power station's cooling system. It was noticed that one of the pumps was suffering from heavy corrosion on outer and inner parts. Corrocoat Indonesia was contracted to surface prepare and apply Poly 100 at 1000 µm and Renderpol as filler material to prevent corrosion failure in the future. Work on the 12m high x 1.8m diameter pump was completed in 10 days.

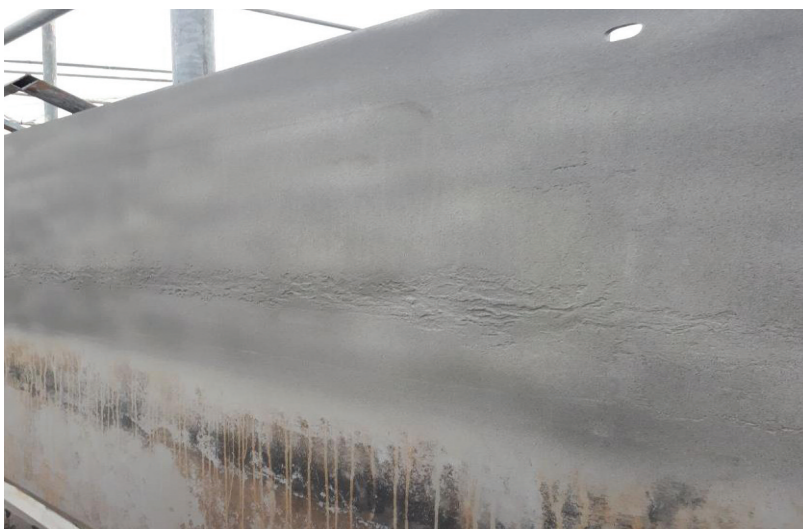
Corrosion was present at the top level of the reactor, so the top 55cm of the wall inside the reactor openings were to be blast cleaned and re-coated to prevent further corrosion. The total area to be treated was 56 sq m. Having lowered the liquid level in the reactor, a check was made to

The reactor wall after blast cleaning showing the anaerobes damage

ensure that there was sufficient oxygen and a total absence of harmful gasses. The area to be treated was blast cleaned to ISO 8501-1 Sa 2, pressure washed with biocidal wash to free the surface from bacteria, water washed and Corroglass VSF applied.

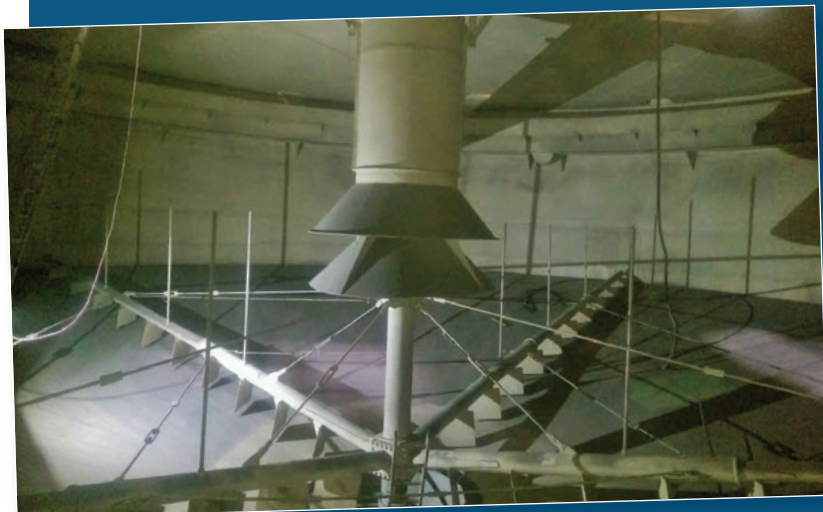
These thickeners are used where potash ores are processed by the hot leaching method. The main problems are high operating temperatures (up to 105°C) and a highly abrasive chemical medium. Surface preparation is a particular challenge due to the high salt content in the atmosphere. A number of coatings had been tried, but all gave poor results.

Corrocoat AKZ's turnkey solution was: thickener barrel internals blast cleaned to ISO 8501-1 Sa 2 then washed with Corrocoat Chlor\*rid solution until the accepted salt level was achieved. All corrosion pits were filled with Corroglass 602, and 610 g/m<sup>2</sup> multidirectional laminating cloth applied to welds, followed by a coat of Corrothane XT at a dft of 700µm. Finally, a second coat of Corrothane XT was applied to build a total dft of not less than 1200µm.

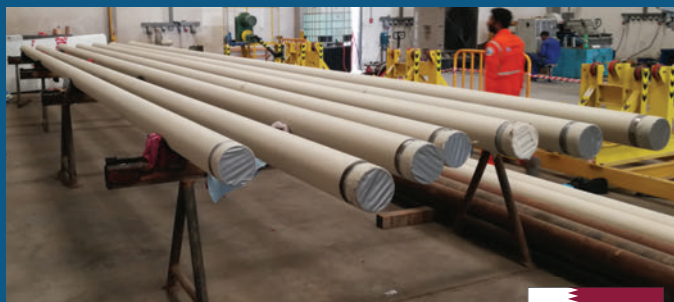
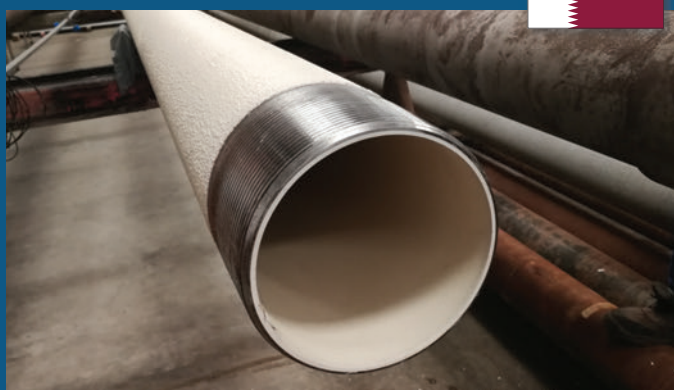
PWI casing pipes used in oil and gas production are subject to high abrasion and chemical attack from the product passing through them and for maximum flow efficiency it is vital that all internal surfaces remain corrosion free and smooth to reduce friction and improve flow.

Having removed all soluble salts and grease, the pipes were abrasive blast cleaned to Sa 2 with a profile of 50 µm minimum. Using their centrifugal pipe rolling rig the internal walls were coated with Polyglass VEPG to minimum DFT of 1,000 µm and the external surfaces airless sprayed with Polyglass VEF to the same thickness.

After thickness and holiday testing and threads application the pipes were returned to the customer where they are now back in use and are performing well.

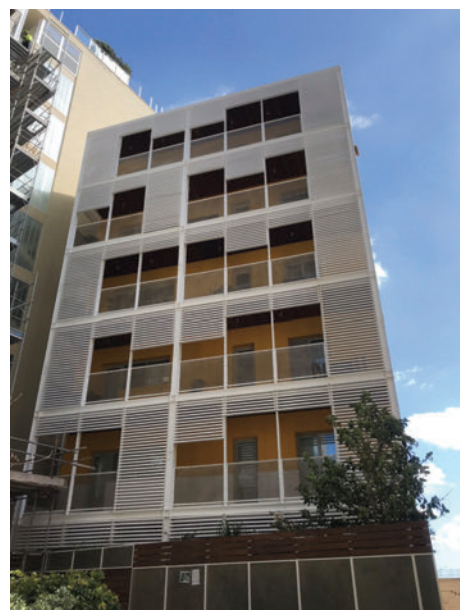
balcony frames and louvres were showing signs of unsightly surface corrosion. Our licensee in Malta – Xn-Teq Company was therefore contracted to prepare and protect the corrosion damaged frames and louvres.

The solution was to remove the metal frames and louvres, then blast clean them to ISO 8501-1

Sa 2. This was followed by hot dip galvanizing to 200 µm, Plasmet Z Galv two pack epoxy coating to 150 µm, and Plasmet ZF to 250 µm. The project is ongoing and is estimated to be finished by late 2018.

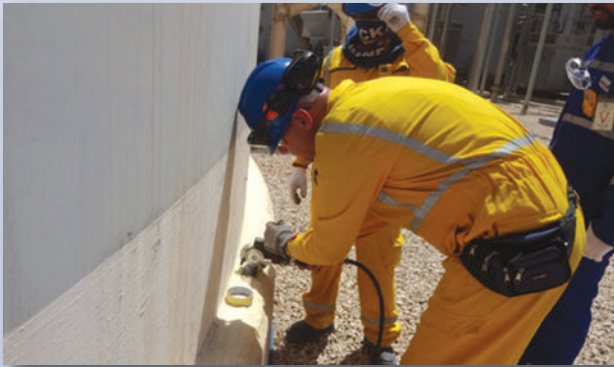
**QAFAC - Qatar Fuel Additives Company contracted Al Huda Corrosion Treatment to repair 30 defective areas of coating on the annular plate rings of four large storage tanks including the lamination of overlap patches. The substrates were carbon steel and concrete.**

To achieve an effective, long-lasting repair, the defective coating was cut out and damaged areas suction blasted

to ISO 8501-1 Sa 2 to a profile of 50 µm. These were primed with Lamination Resin 200 then filled and reprofiled using Corroglass 202, followed by lamination by multi-directional Fiberglass Cloth and L200 Laminating Resin.

After a final topcoat of Corroglass 232 & 252, the dry film thickness was checked with a coating thickness gauge and spark tested at 6 kV to ensure the absence of pin holes.

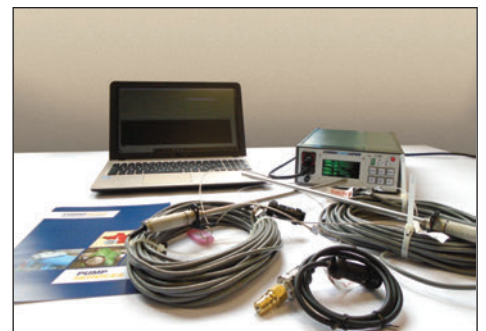
The unit measures two parameters (temperature and pressure) at the pump suction and discharge to compute pump efficiency. By inputting the motor power consumption, the system calculates the flow rate. The performance test proceedings are for class C pumps (industrial). The TPM unit uses real time monitoring data, manual input values and algorithms to calculate pump performance.

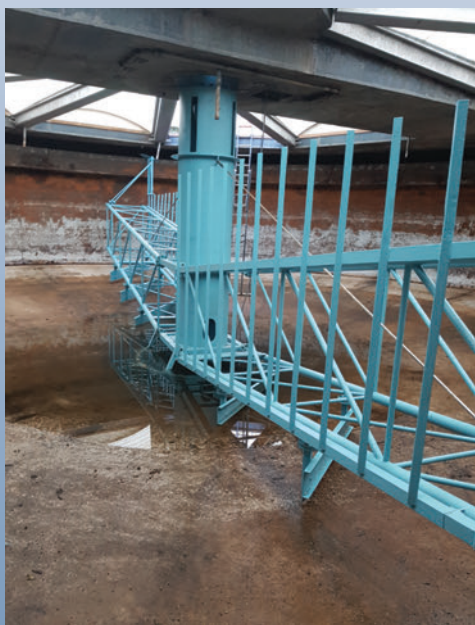
The mixer had been coated with a conventional paint system but due to the fact that iron chloride was now present in the chemical process, this paint system was no longer resistant and corrosion had started to occur. Corrocoat's solution was to coat the mixer with Corroglass 600 system and VS with a dft of 800 – 1000 µm after first blast cleaning to ISO 8501-1 Sa 2.
